# Manhole Inspection Summary

Manhole # S15C1\_014MH

Insp Date: **5/28/08 10:48 AM**

**Location** Address: **2930 james st**

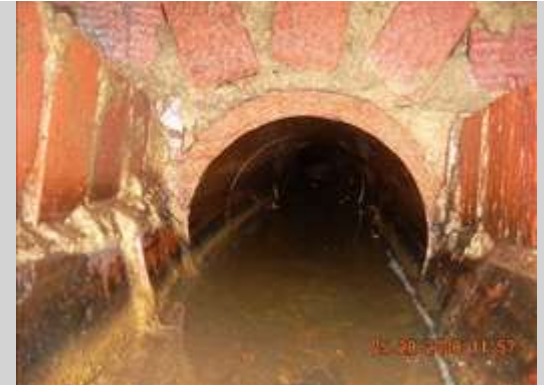
12 O'Clock Outflow

8 in. Circular Gravity Sewer  
Pipe Out @ 12 O'Clock

Invert Depth: **14.05** (ft.) Flow Characteristics: **Slow**

Infiltration: **None** Pipe Seal Cond: **Sound**

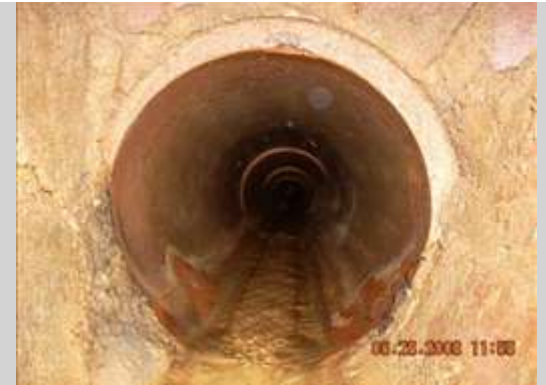
6 O'Clock Inflow

8 in. Circular Gravity Sewer

Pipe In @ 6 O'Clock

Infiltration: **None** Pipe Seal Cond: **Sound**
